A Long Lesson in Resiliency: Ha Ha Tonka Karst Natural Area

by Allison J. Vaughn

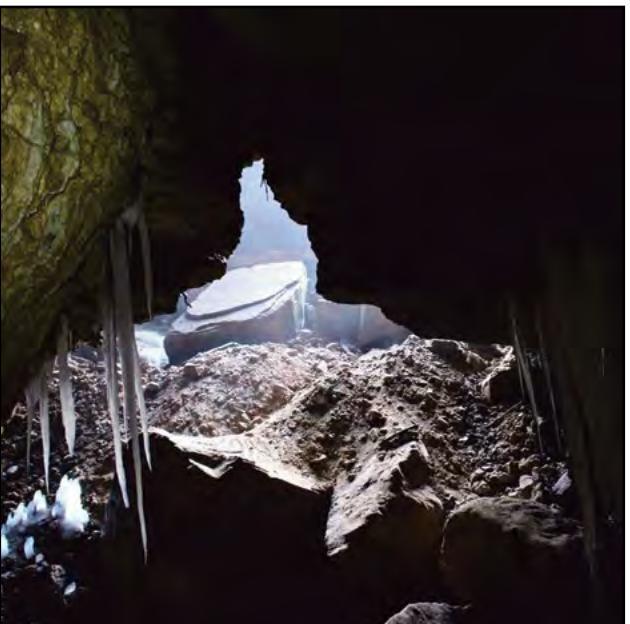
Image 2. The left side of the main River Cave entrance in the winter after the debris collapse in July essentially blocked air flow and passage with boulders and gravel fines. A large section of the entrance was cleared of debris in August, 2015, but some still remains.

west sinkhole. The intensity of the flooding and whirlpool effect promulgated by the gate blockage resulted in a massive land slump in the west sinkhole which partially blocked the cave entrance and destroyed the 20 ft. tall primary chute gate built to allow for bat passage. The land slump left large boulders, gravel, and soil in front of the primary passage, thereby altering the airflow into the cave (Image 2). River Cave is home to a significant maternity colony of endangered gray bats, estimated at 150,000.

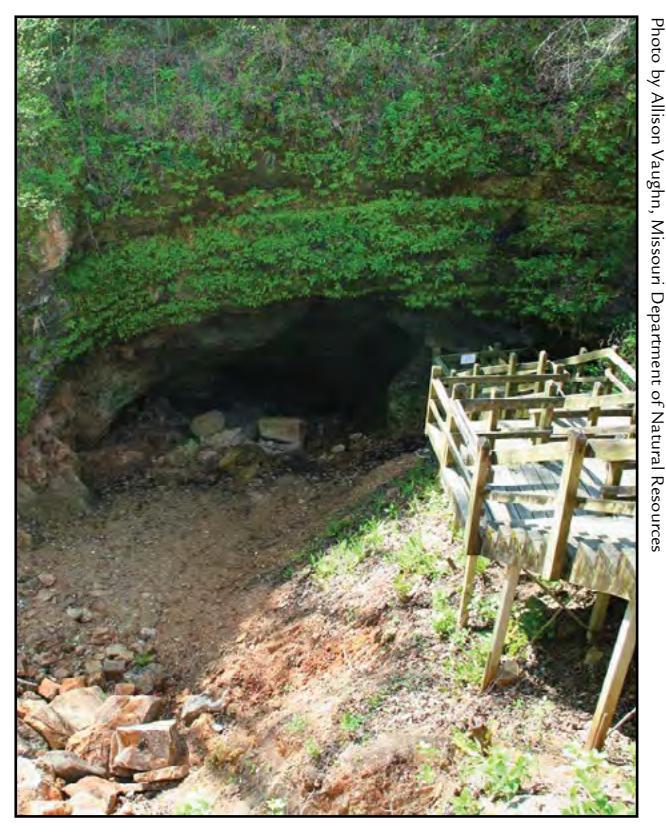
Image 3. After the debris from the flood event was removed, contractors also removed tons of steel from the chute cave gate, revealing the natural entrance to River Cave. The cave gate was replaced the same week to prevent trespass. The wooden steps leading into the sinkhole remain out of commission in 2024 due to instability of the hillside in which the steps are anchored.

Shortly after the rain event, MDNR hydrologists, engineers, and Missouri Geological Survey (MGS) staff assessed the damage and provided a strategy to mitigate continued gravel input in the cave. In an unpublished MGS report, it was recommended to culvert the road out of the stream bed, and for park staff to seek permission to remove gravel following heavy rain events from the stretch of the stream on park property above the east entrance to River Cave. Included in the report was a recommendation to ultimately seek funding to pave Dry Hollow Road and dredge gravel out of Ha Ha Tonka Spring. The immediate work ahead involved a FEMA contract utilizing cranes and bulldozers to remove debris and the 20 ft. tall damaged cave gate, which consisted of several tons of steel, from the primary sinkhole entrance to River Cave (Image 3). This costly endeavor resulted in park staff and volunteers tackling the debris in the east sinkhole by hand with buckets. The FEMA contract also funded the cave gate replacement that was built by park staff and Americorps-St. Louis.

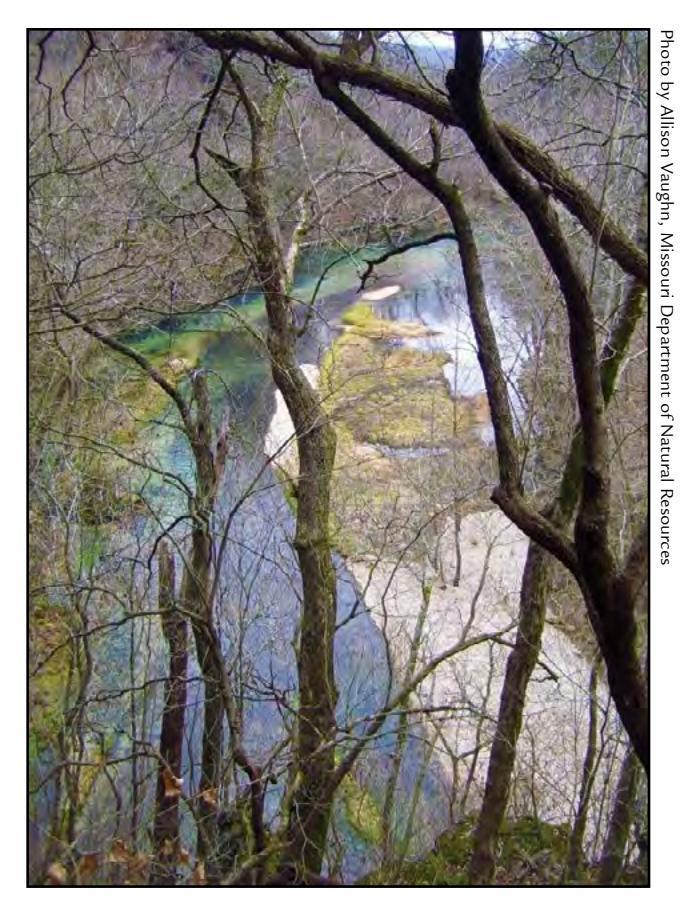
Image 4. Gravel islands formed quickly in Ha Ha Tonka Spring as this photo from 2016 illustrates. By 2020, the islands were vegetated with roadside vegetation, including tall fescue.

The sump at the back of River Cave continued to clog with gravel as it coursed its way through the cave, with hydrostatic pressure ultimately forcing the gravel through the underground conduit and into the spring. Spring discharge is strong enough to move large amounts of gravel. However, through time, improvements to Dry Hollow Road and regular gravel removal from the stream slowly began to lessen the gravel input in the cave, but there remained much in the cave system. By summer 2016, large gravel islands with roadside vegetation began to develop in the spring (Images 4 and 5).

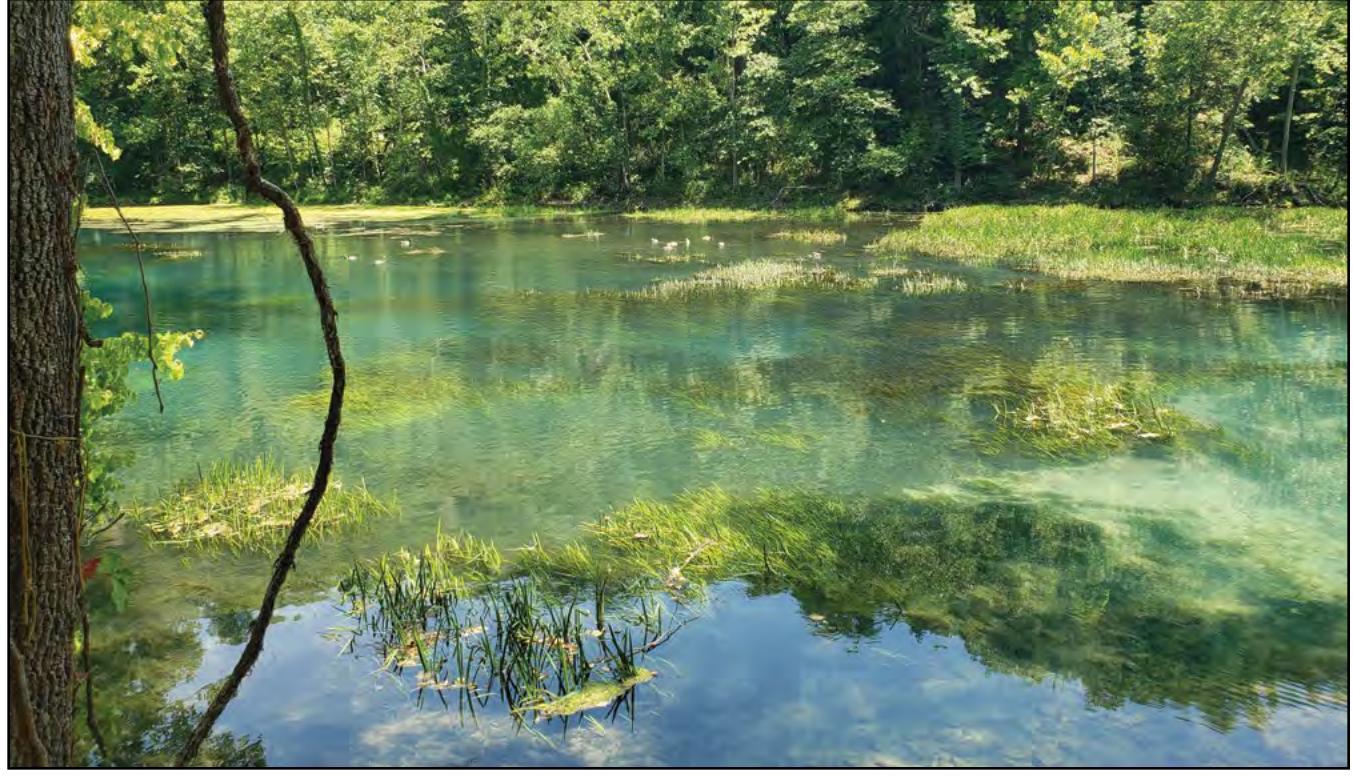
Image 5. By August 2023 two months after the dredging project ended, native spring vegetation had recolonized the spring.

In late 2022, after much planning and securing of additional grant funds, Camden County paved the one mile stretch of Dry Hollow Road that was impacting the stream. By this time, River Cave and Dry Hollow Stream possessed far less gravel than in previous years, and with the paving of the road, the gravel input is now slated to come only from the stream and surrounding watershed. The next activity was to secure funding for the dredging of the spring. Understanding the significance of this natural feature in the park, MDNR funded the dredging through the Fiscal Year 2024 Capital Improvement Budget. Research into this project involved using late 1970s reports from then-Division of Geology and Land Survey's (now MGS) renowned hydrologist Jerry Vineyard, his landmark book Springs of Missouri (1982) and images of the spring from Steyermark's 1940 publication. MDNR staff collaborated with engineers and spring experts to determine the historic depth of the spring. Permitting and planning required significant effort from both MDNR and the engineering firm, but in summer 2023, the two months-long dredging project concluded in early June with the final total removal of 10,565 cubic yards of gravel and road fines. The isolated gravel islands that had formed from the deposition of gravel from River Cave over eight or more years were removed.

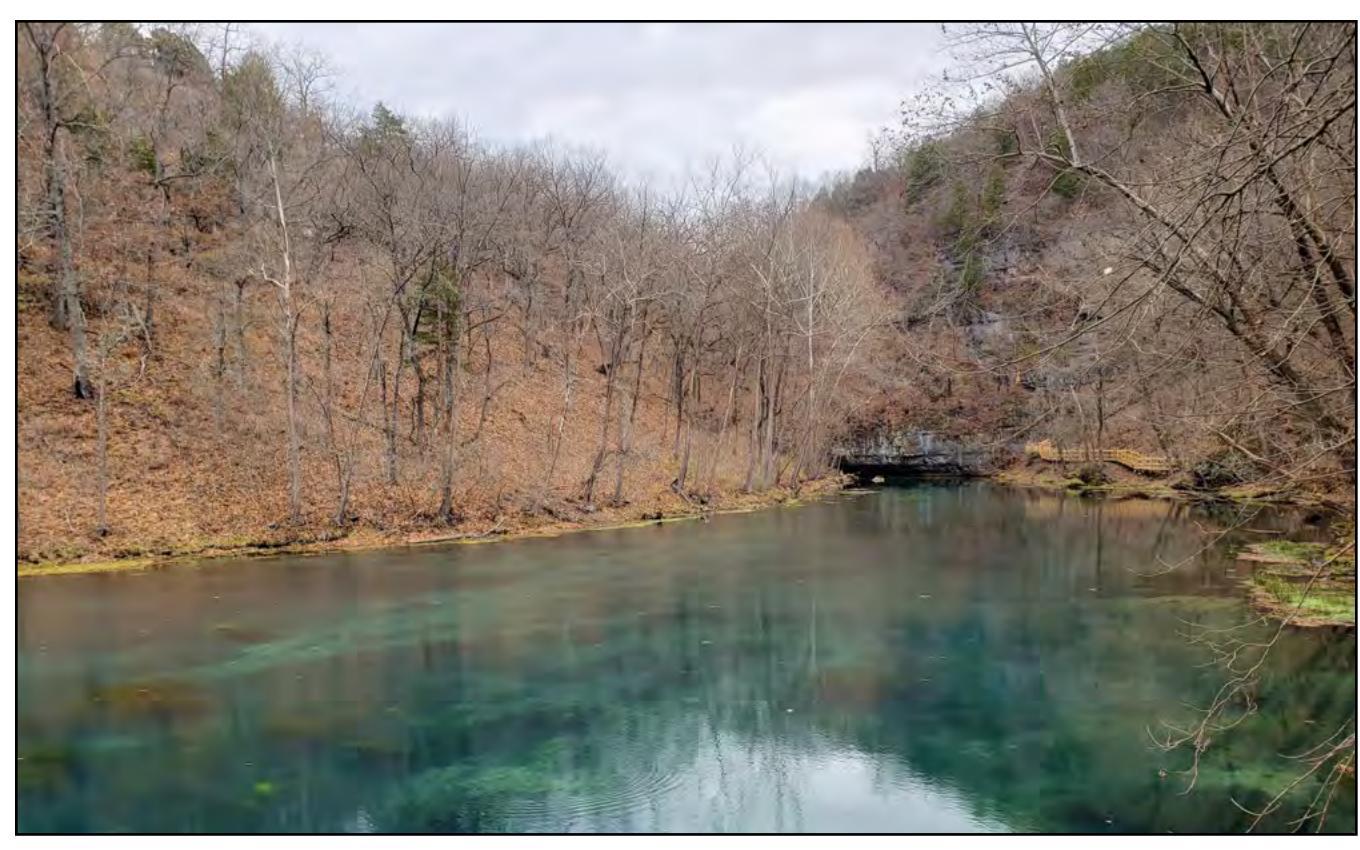
Image 6. Ha Ha Tonka Spring in November, 2023 after the native spring vegetation went dormant.

To undertake this project, terrestrial vegetation typical of a dry-mesic limestone forest along the lower Spring Trail was negatively impacted to allow passage for dredging equipment. Efforts were made to prevent erosion after the operation was complete, and it is hoped that through time, the herbaceous vegetation will recover. To conduct the gravel dredging, contractors created a wide passage along the Spring Trail at the base of the forest, and a gravel road into the heart of the spring pool for the equipment to reach the gravel islands slated for removal. Notably, by August 2023, spring vegetation, including mats of watercress at the bottom of the spring, burreed, water milfoil, hornwort, water speedwell, and water starwort began to repopulate the spring and spring branch (Image 6).
